**MERRIMACK RIVER BASIN
NEW DURHAM, NEW HAMPSHIRE**

**MERRYMEETING LAKE DAM
NH 00342**

**PHASE I INSPECTION REPORT
NATIONAL DAM INSPECTION PROGRAM**

OCTOBER 1978

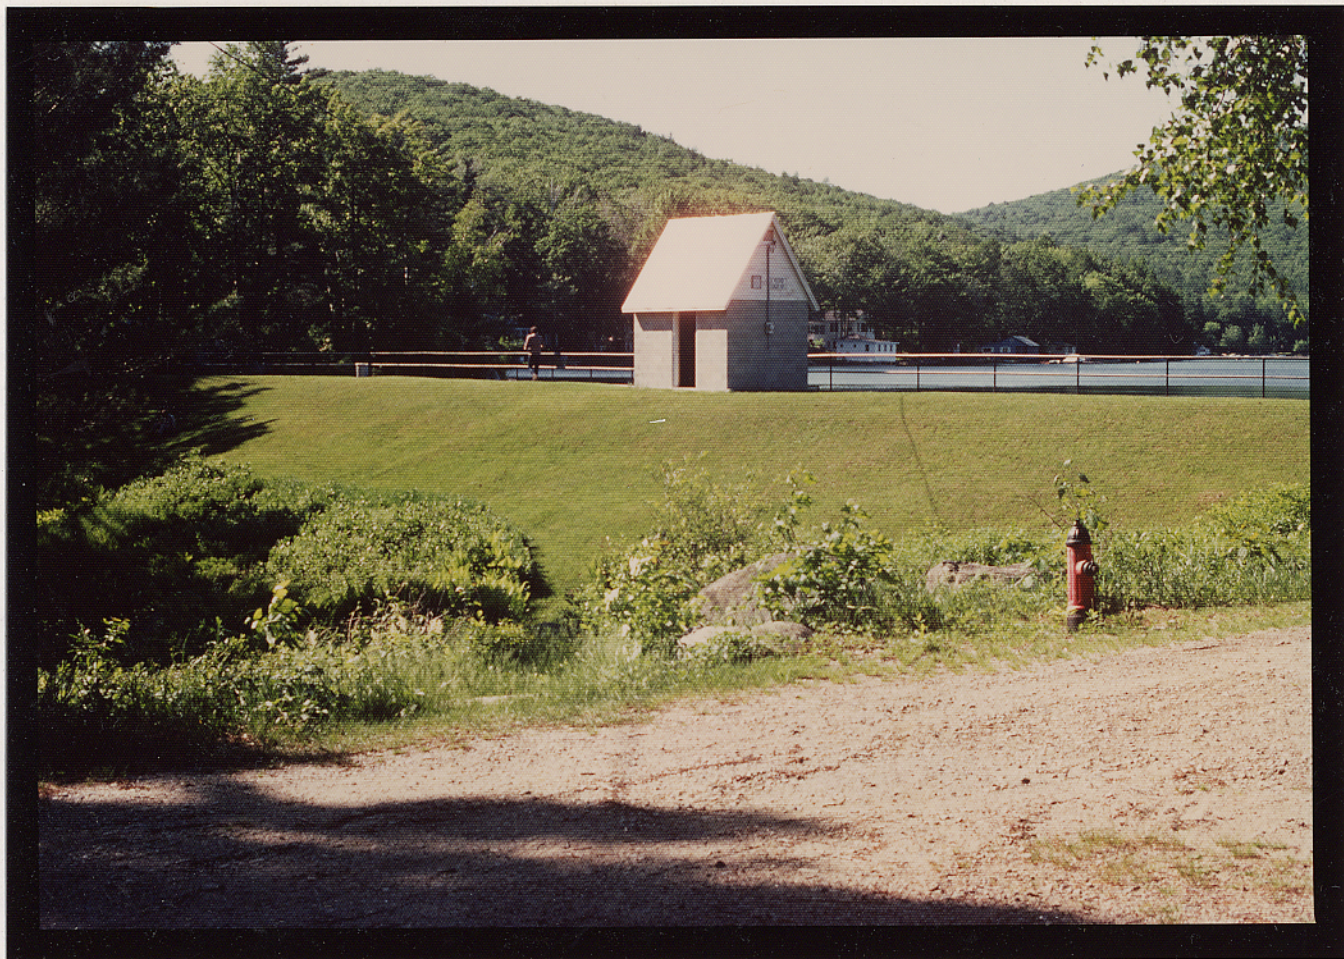
View of the dam from the downstream side. The low level outlet gate house is in the center. The zone of seepage is demarcated by the end of the cut grass area and the swamp-type vegetation below it.

A zone of seepage was observed in the downstream face of the embankment, approximately 11 feet below the top of the embankment and extending from a point about 54 feet to the right of the low level outlet continuously to a point about 36 ft. to the left of the outlet. The seepage was clean at the time of the inspection. While a considerable quantity of water was observed, an accurate estimate of the seepage could not be made due to the extent of the zone. A measurement made in March 1965, however, records the seepage as being 79 gpm, based on a stream gauge at the Powder Mill Fish Hatchery.

The seepage of the embankment is of concern, even though the operator of the Fish Rearing Station has stated that the dam's seepage condition is stable and unchanged in the 28 years he has operated it, going back to 1950. It is unclear whether the addition of the new concrete facing wall on the upstream face of the dam has reduced seepage volumes. It is also not clear whether the seepage observed has any connection with the cobble drains installed under the embankment, according to available plans. Further investigations will be recommended to evaluate the source and seriousness of the seepage.

It is recommended that the owner, within 12 months after receipt of this Phase I Report, acquire basic engineering data that would allow the proper assessment of the seriousness of the observed seepage and its effect on the stability of embankment's toe slope.

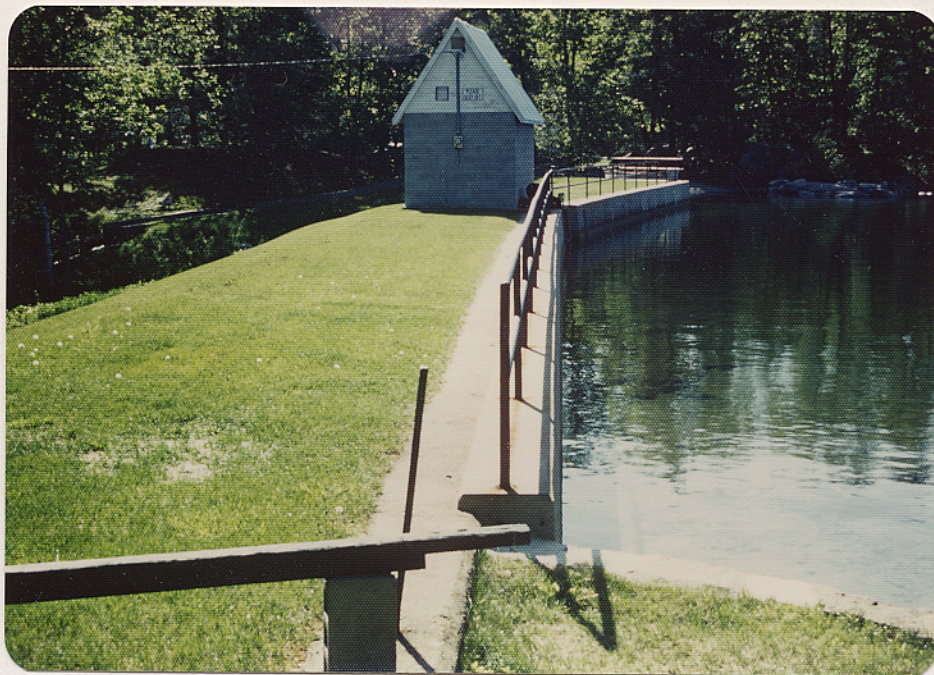
Photo 1 - View of the dam from the left abutment showing the upstream masonry wall and the downstream embankment wall.

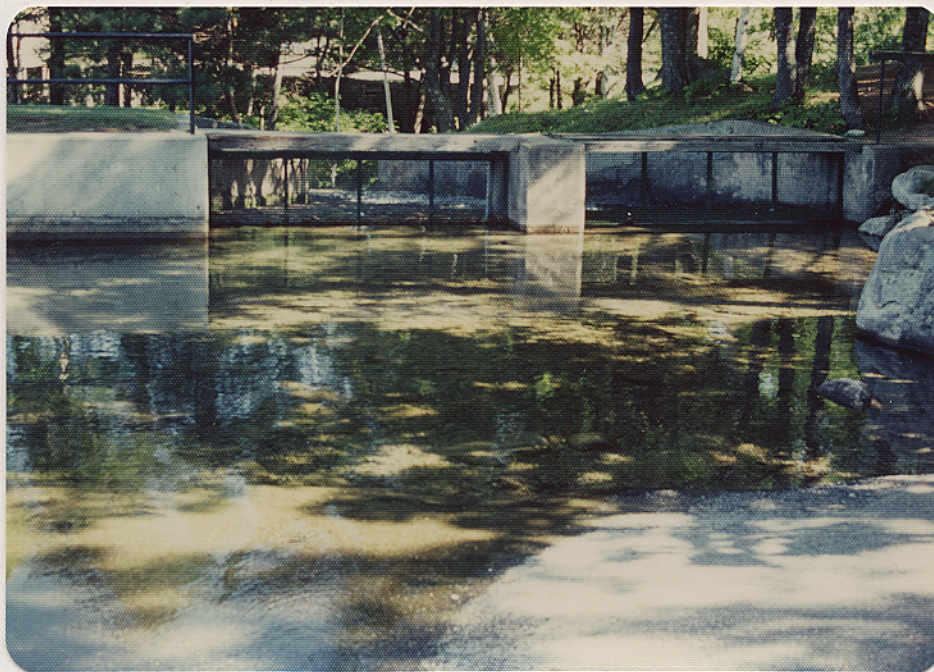
Photo 2 - View of the left abutment, showing the spillway chute entrance area.

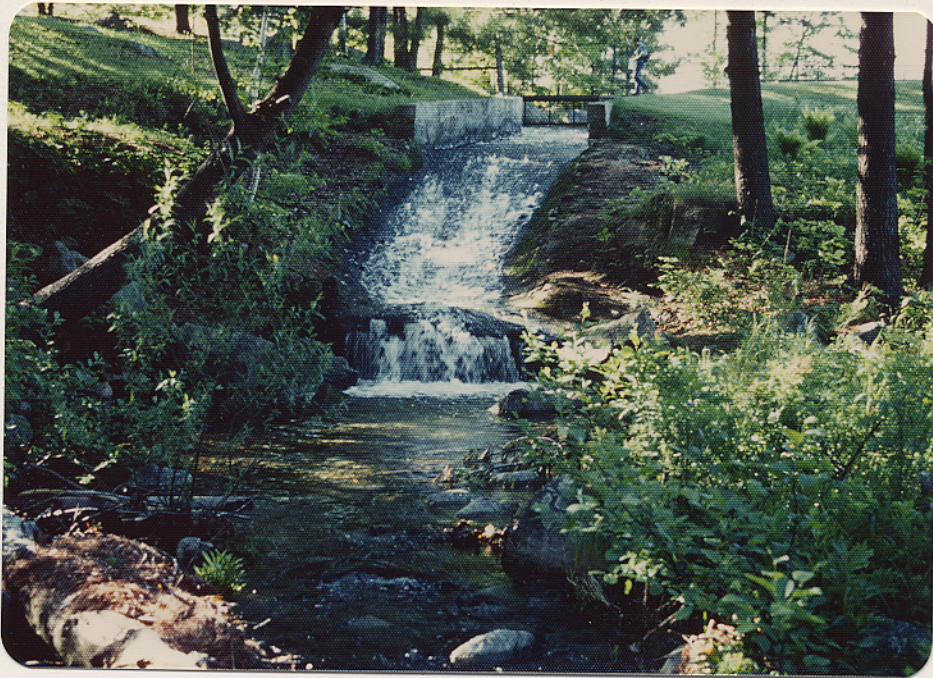
Spillway. The spillway consists of a concrete crest 20-foot long transitioning into a 10-foot wide spillway chute channel. The spillway chute walls are 3-foot high and are built of cobble masonry whose joints are slightly deteriorated. The upper chute floor is rough finished. At the end of the walled chute section, the floor slab continues for another 20 feet. In this section, the grade is a little steeper than in the upper chute, and the walls are discontinued. To contain and control the chute water, the floor slab in this section is dished. The construction joint between the two chute slab sections is eroded and irregular. At the end of lower chute slab, the spillway water drops approximately 2 feet and enters a natural channel with a rocky bottom, which joins the channel of the Merrymeeting River some 200 feet downstream of the dam axis.

Photo 3 - View of the spillway chute from the downstream side. Note the section of the spillway with side walls in the background, and the drop in chute grade in the foreground.

VISUAL EXAMINATION OF	OBSERVATIONS	REMARKS AND RECOMMENDATIONS
CONCRETE WEIR	The weir crest concrete has been refurbished. The chute walls are of mortared masonry construction. Some cracking of mortar joints, and deterioration of joints is visible.	No action required.
APPROACH CHANNEL	Shallow abutment area of Merrymeeting Lake, no approach paving is visible.	
DISCHARGE CHANNEL	The discharge chute channel slab is 10-ft wide by 55-ft long, and is paved with rough finished concrete for the first 45 feet. The last 20 ft surface is concrete with smoother finish. The concrete is in good condition, no visible cracking or distress. The joint between the two sections is eroded. The natural channel downstream of the concrete chute drops two feet and is subject to erosion and could undercut the concrete chute.	Protect the natural spillway discharge channel with bank and bottom stone armoring. Eliminate all sudden grade changes by filling in with stone.

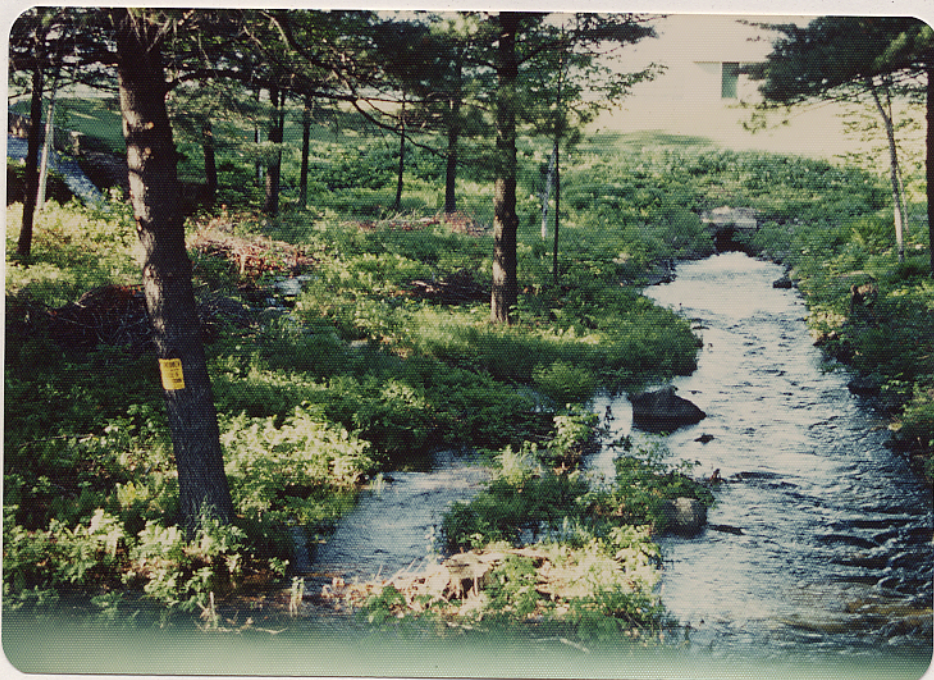
The tailwater at the dam is affected by the inadequate capacity of the roadway bridge opening downstream of dam which could cause embankment toe sloughing and slumping at high discharges. The inadequate roadway bridge opening can be further restricted by falling trees or logs in the reach between the dam axis and the bridge.

Photo 4 - View of the downstream channel of the Merrymeeting River from the road crossing below the dam. The low level outlet dam embankment and the outlet gate house are in the background.

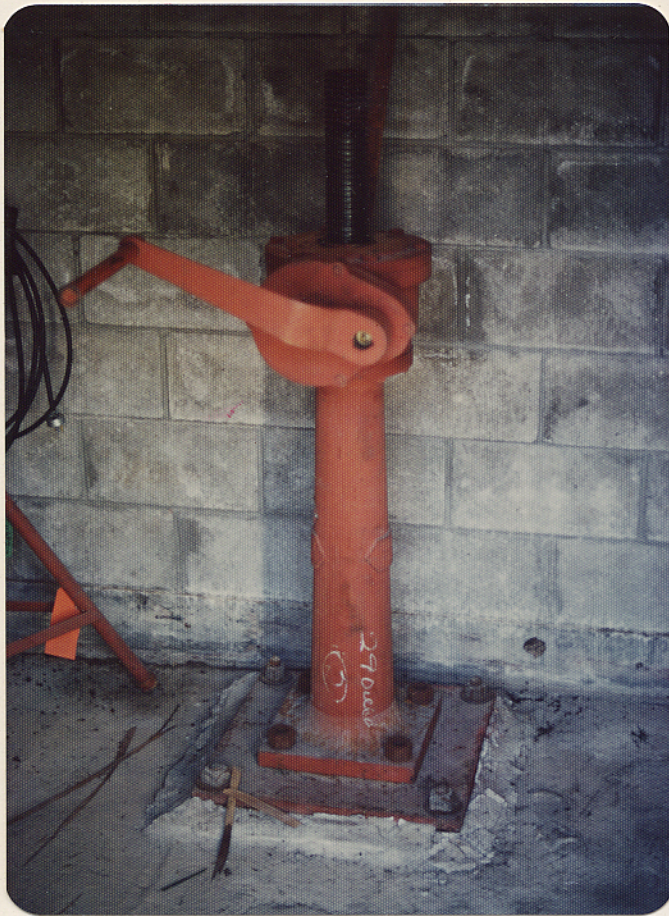
In 1969, the present sluice gate hoist replaced the original hoist which was installed in 1923. The original hoist utilized a large handwheel for motive power. The original gate stem is still being stored in the gate operating house, even though it is not interchangeable with the present stem.

In general the equipment appeared to be in excellent condition. Low level outlet discharges are estimated from curves correlated to lake surface elevations and gate openings.

Photo 5 - View of the gate hoist
inside the gate house.

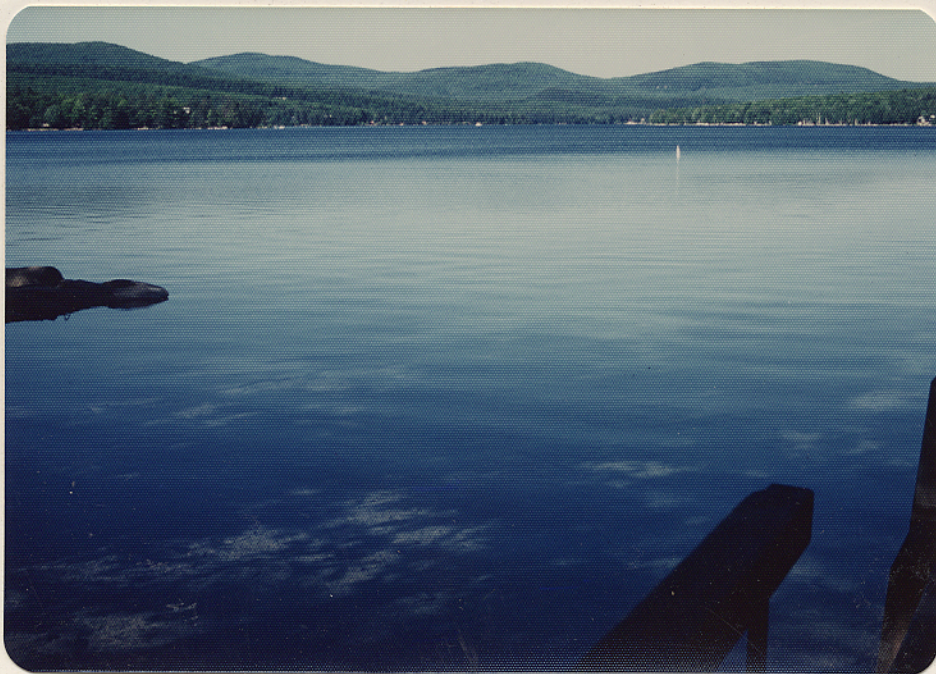
Photo 6 - View of Merrymeeting Lake rim taken from the dam axis.
